Short Report

HDV (Heavy Duty Vehicles) NO_x emission measurement with “Plume Chasing” and subsequent inspection of high emitters

*A study in Flanders (Belgium) November
/ December 2021*

Date: 22.06.2022

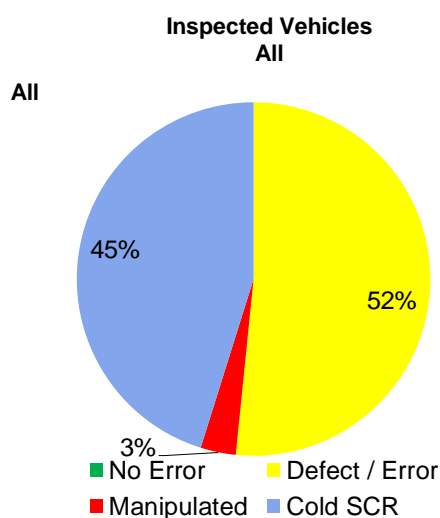
Figure 2: Conclusion of the inspected HDV for EURO V and VI excluding vehicles where the measurement system indicated a SCR warm up, emissions were low or too few data points were recorded. The percentage is relative to the inspected HDV.

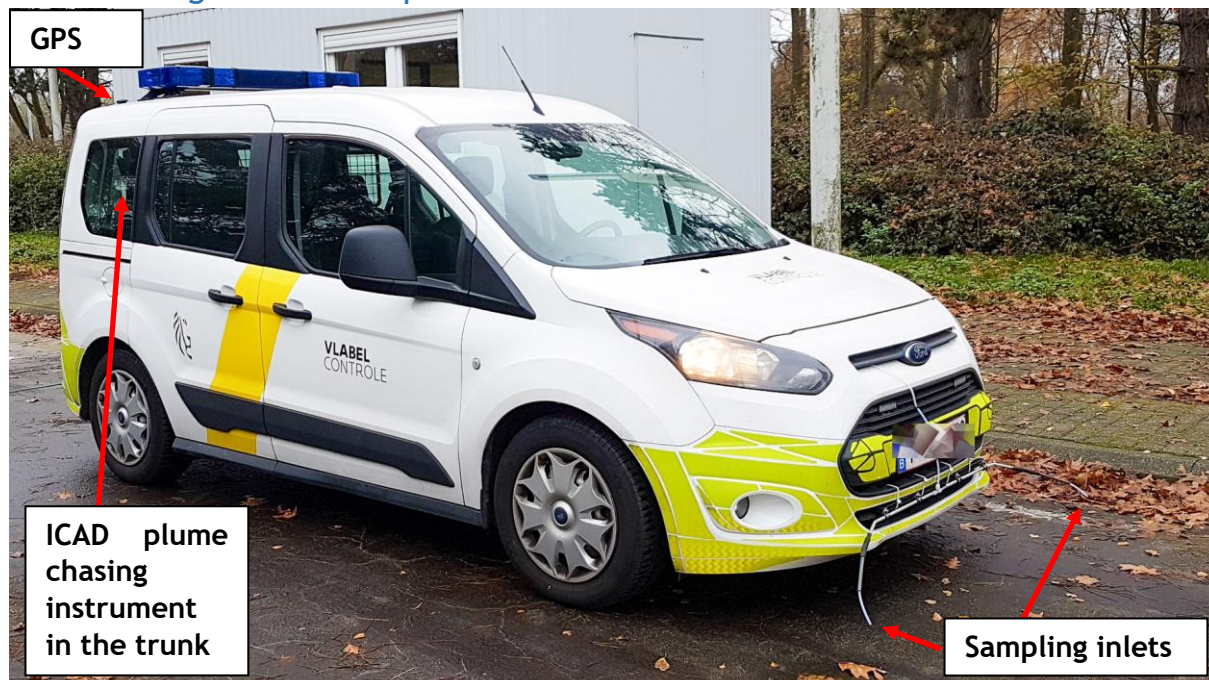
Figure 4: Plume chasing installation on the Vlabel Controle vehicle (outside view). Two sampling inlets are combined to one sampling hose to the ICAD plume chasing instrument in the trunk.

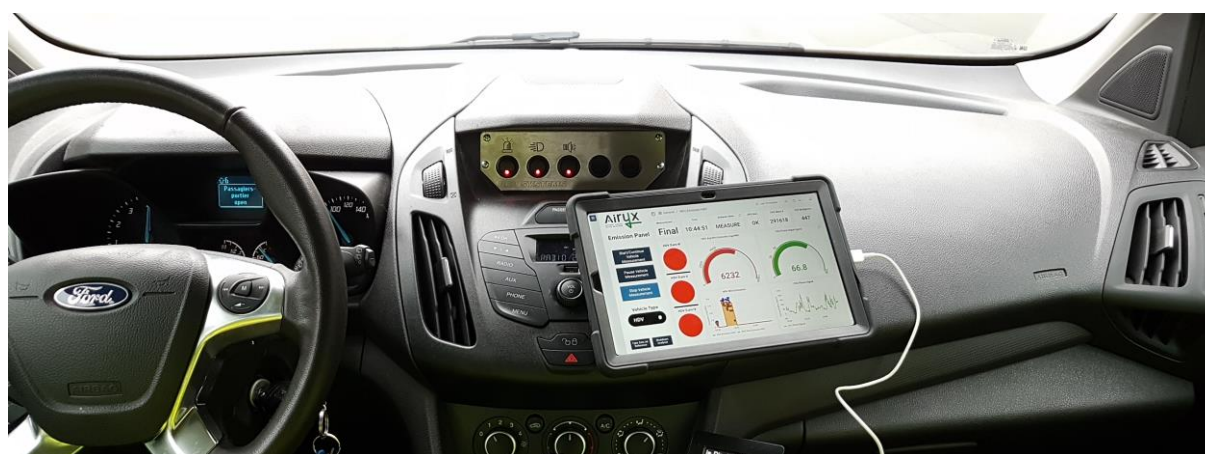
Figure 7: Display installation in the cockpit. A tablet is used to display the real time data and is connected via WiFi to the ICAD instrument. It allows operation and visualisation.

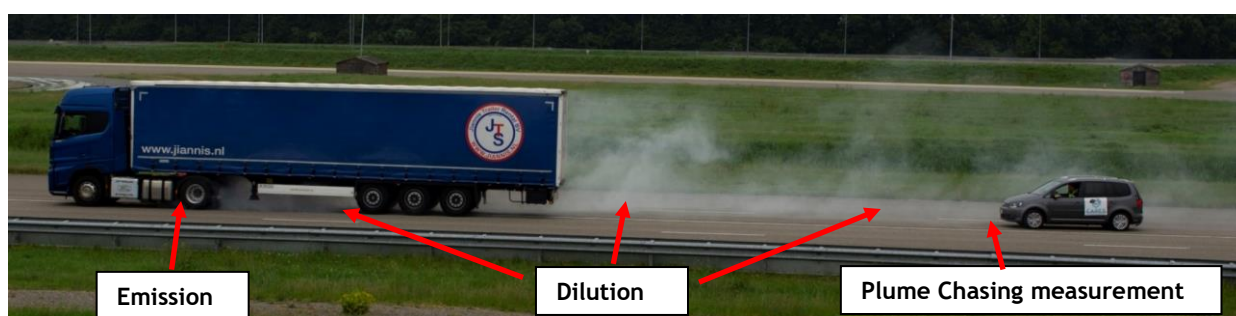
Figure 8: Illustration of plume chasing measurement configuration. The emitted exhaust gases are diluted. The plume chasing vehicle measures the gases in the diluted plume. Exhaust gases visualised in this picture with white smoke.

The measurement configuration of an inspected HDV with the chasing vehicle in the exhaust plume is illustrated in Figure 8.

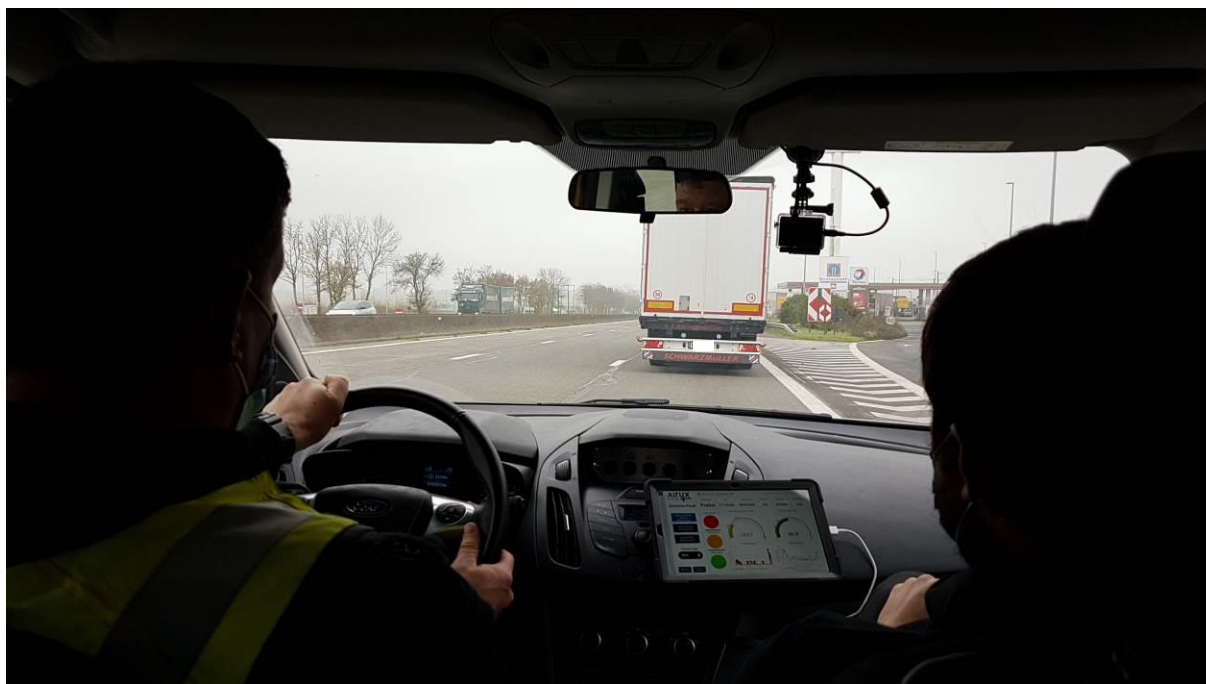
Figure 12: Picture inside the plume chasing vehicle during measurements.

The plume chasing car was operated by Vlabel controle, following different HDV as indicated in Figure 12. As the plume chasing vehicle was a Vlabel controle vehicle it could directly stop the trucks. Additional other Vlabel controle inspectors with other cars or motorbikes accompanied the measurement and often performed the HDV inspection. Thus more HDV could be investigated with plume chasing measurement vehicle while other Vlabel control officers performed the inspection.

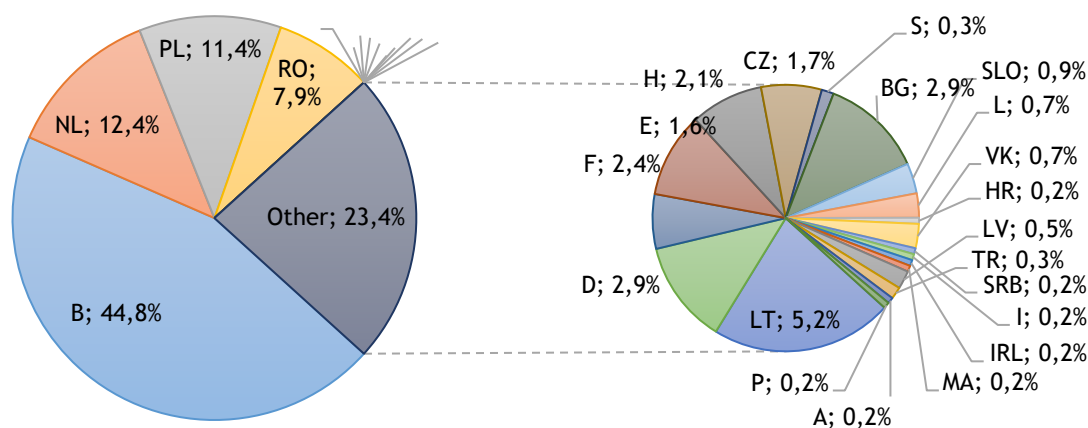
Figure 14: Distribution of origin for the measured HDVs in percent.

For 580 HDVs, a country of origin was read from the number plate. In some cases, the number plate could not be read. The largest group are from Belgium (45%) followed by the Netherlands (12%), Poland (11%), Romania (8%) and Latvia (5%).

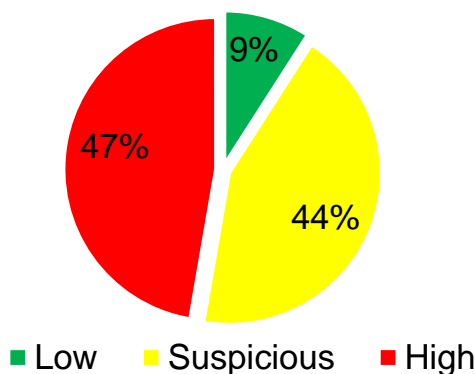
Figure 32: Emission classification of the inspected HDV.

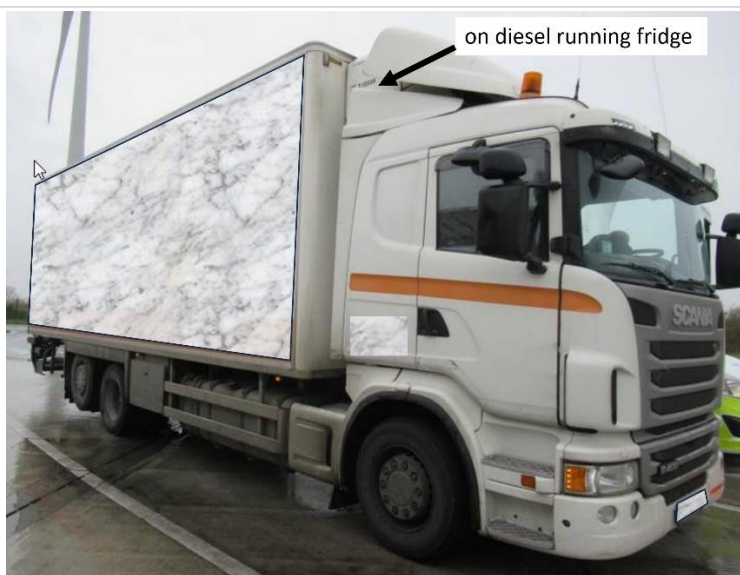
Figure 41: Time series of NO_x emission factor for measured HDV no 215 (EURO V), where a fridge running on diesel was identified as the source.

The second HDV in this group had a diesel powered refrigeration unit, very likely leading to the high emissions observed (chapter 7.1.1).
